NASA Technical Memorandum 102371

Characterization of Failure Processes in Tungsten Copper Composites Under Fatigue Loading Conditions

Yong-Suk Kim, Michael J. Verrilli, and Timothy P. Gabb
Lewis Research Center
Cleveland, Ohio

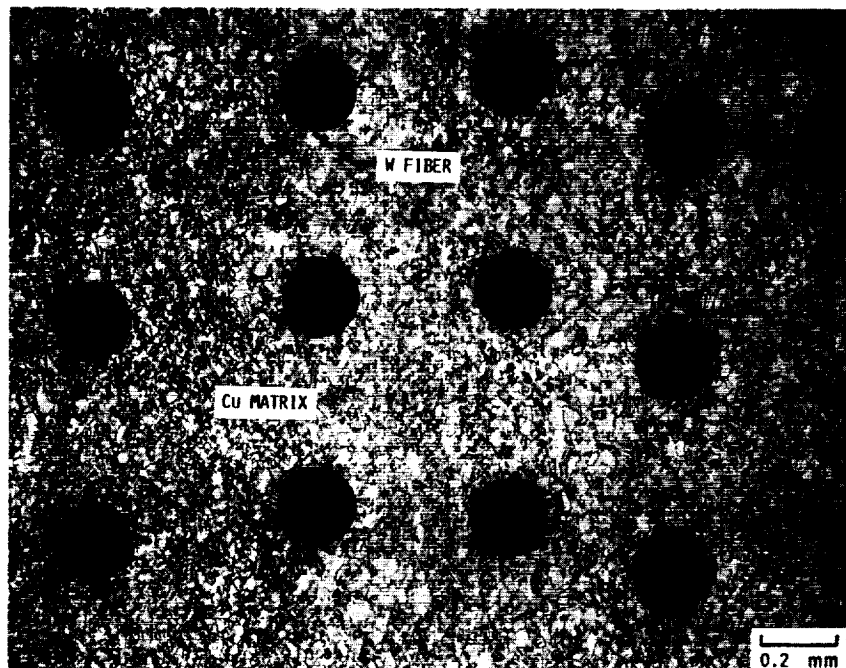
The microstructure of the as-received composite was examined with an optical microscope (fig. 2). Figure 2 shows both the Cu matrix and the periodically arranged W fibers. The interspacing between fibers is not regular, and the matrix grain size varies with locations. Figure 3 is an enlarged micrograph of the as-received composite. The uneven grain size distribution in the Cu matrix is well displayed. The grain sizes are in the range of 8 to 15 μm . Usually, finer grains are observed near the fiber, whereas large grains occur between fibers. No interface reaction products were observed, which is consistent with other studies (refs. 1 to 10).

FIGURE 2. - AS-RECEIVED COMPOSITE SHOWING PERIODICALLY ARRANGED W FIBERS IN THE Cu MATRIX.

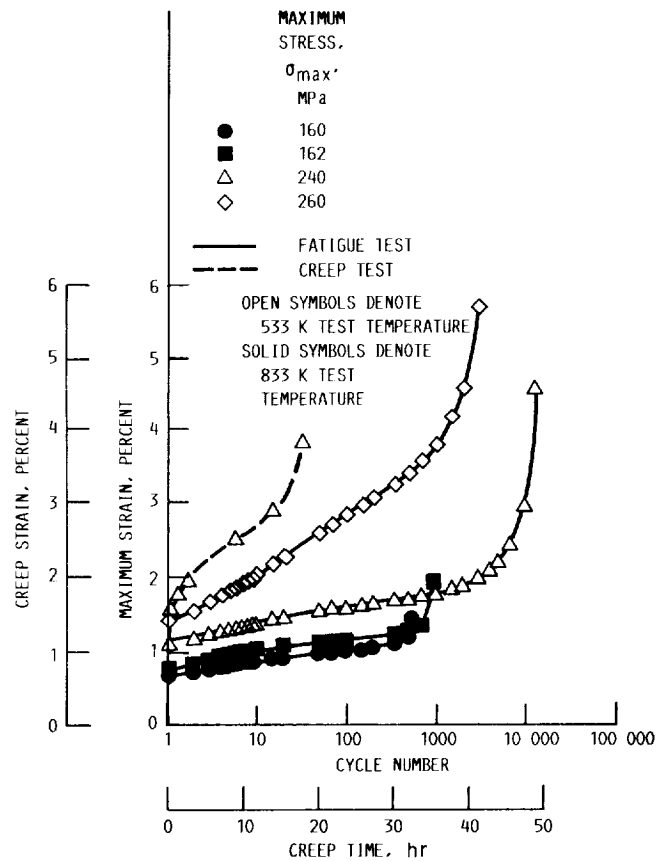
Figure 4 shows some of the fatigue test results as a linear-log plot of the maximum cyclic strain per cycle versus the applied number of cycles. Test results from both 533 and 833 K are plotted together. At both temperatures the maximum strain in each cycle increases (ratchets) continuously until the specimen fails. This behavior is analogous to typical secondary and tertiary strain versus time behavior in the creep of a monolithic material. For comparison, the results of a creep test for the composite at 533 K is also shown in figure 4, as a linear-linear plot of strain versus time. This similarity in behavior will be shown to extend to the matrix failure mechanism as well. The total failure strain increases with increasing maximum cyclic stress at both temperatures. The total failure strain of the specimens tested at 533 K is larger than that tested at 833 K. Additional mechanical test results are reported elsewhere (ref. 11).

FIGURE 4. - MAXIMUM CYCLE STRAIN VERSUS NUMBER OF CYCLES FOR 9 vol % W-REINFORCED Cu TESTED UNDER LOAD-CONTROLLED FATIGUE AT 533 AND 833 K. FOR COMPARISON, A CREEP CURVE OF THE COMPOSITE AT 533 K AND AT 240 MPa IS ALSO SHOWN.
